POST-BUCKLING TEST RESPONSE AND ANALYSIS OF FIBER COMPOSITE GRID-STIFFENED STRUCTURES

ABSTRACT

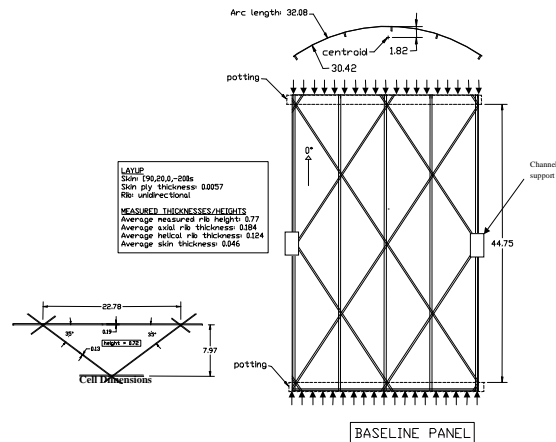
Figure 1. Baseline Panel Design

In the spring of 2001, Boeing (Van West, 2002) fabricated a cylindrical test panel using a representative grid-stiffened fiber composite design (Figure 1). This cylinder was subsequently partitioned into three test panels and several small test coupons. The larger test panels included a baseline design with no extraneous features such as pad-ups, portal block-outs, or connections. This panel was subjected to a compressive static load test at Boeing Phantom Works. The top and bottom surfaces of the panel were potted in epoxy to allow more uniform distribution of bearing stress into both the rib grid and the skin at the loading platens. The baseline panel design was subjected to a constant displacement rate to failure. Active instrumentation included a distribution of unidirectional strain gages on the ribs to monitor axial strain and bending effects, combinations of unidirectional and Rosette strain gages on the skin, and acoustic sensors to assess timing of damage events (Figure 2). Also, high-speed video monitoring of the grid side of the panel and an array of 250 reflective targets applied to the external skin surface were used to monitor the progression of displacement patterns on the skin (Figure 3).

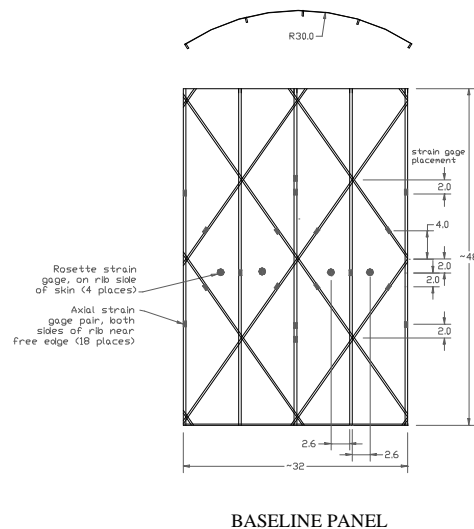
Figure 2. Active Instrumentation Layout.

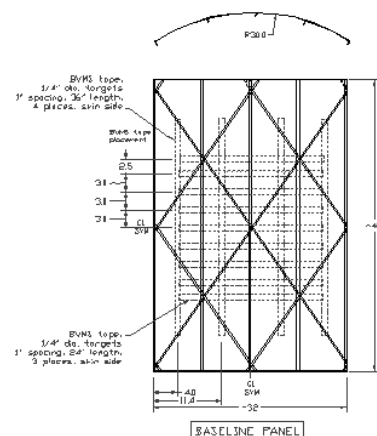
Figure 3. Photogrammetric Target Distribution.

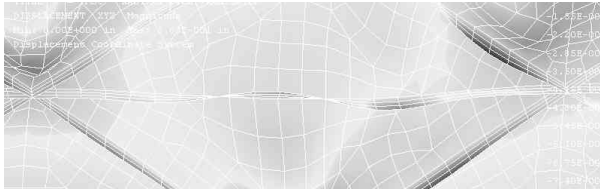
Figure 7. Circumferential Displacement Fringe from AFRL Analysis (10x) at 177,801 N Panel Load at the Location of the Initial Buckle in the Test

Complex rib deformations are also seen to develop in the AFRL deflection analysis (Figure 7).

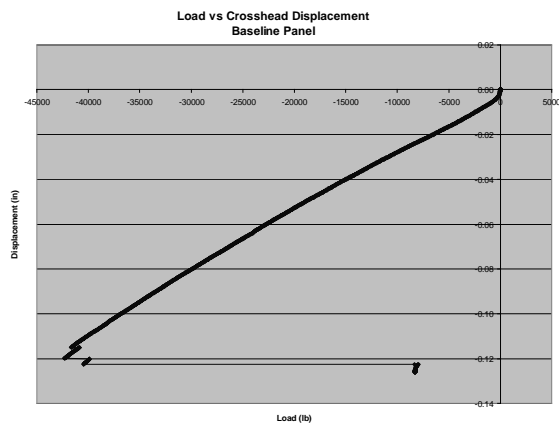
Figure 9. Load –Deflection Measurement for Baseline Panel Test

The baseline panel in the Boeing compression test responded with roughly linear load-deflection resistance to failure at 188,160 N maximum load with some cracking and softening behavior above 177,801 N (Figure 9). This is in good agreement with the Collier post buckling analysis for this test reporting a maximum buckling load of 189,806 N.

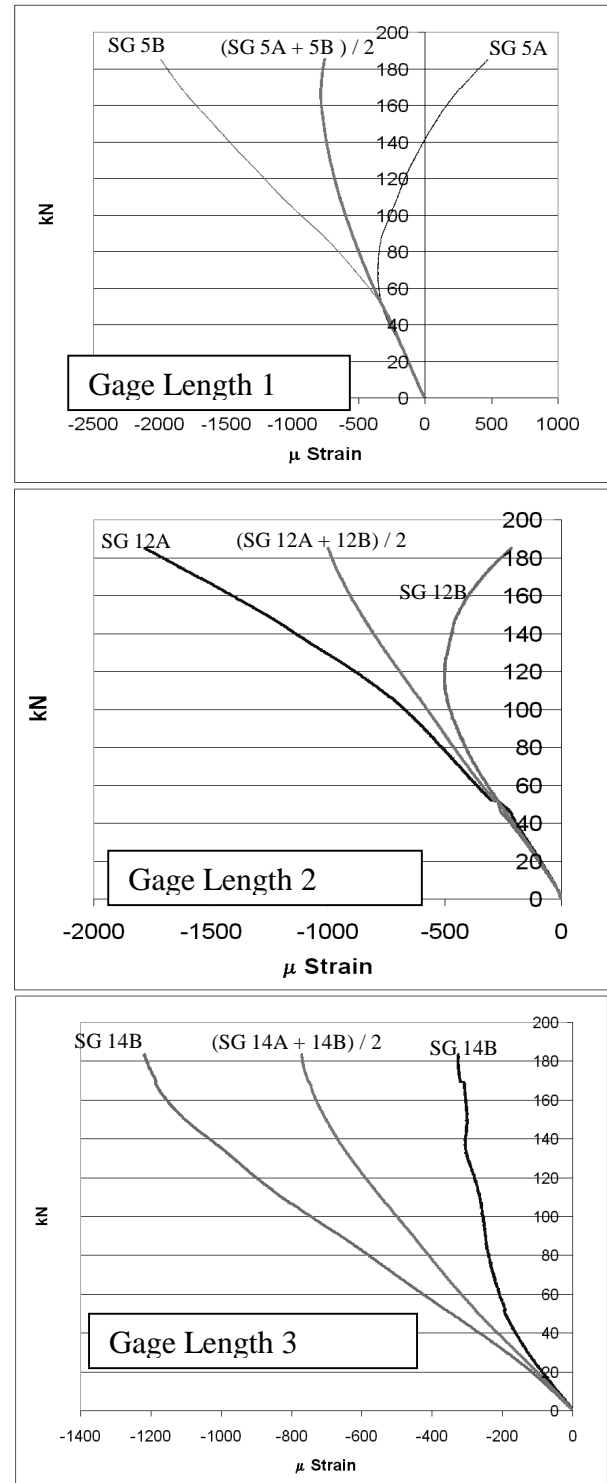
Figure 12. Axial Strains at Points along Axial Rib Gage Lengths 1, 2, and 3.

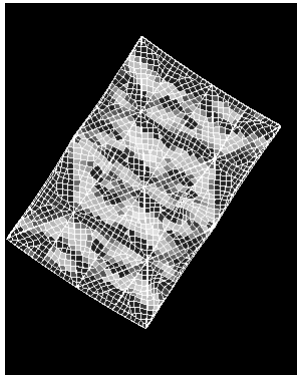
Figure 13. Maximum Principal Stress (Hoop Skin Stresses).

maximum total load of 177,801 N. In this analysis stresses are reported for the middle shell location to omit bending effects in the various structural components and to more clearly show the distribution of primary forces in the panel (hoop and axial). The maximum principle stresses in the skin were oriented in the circumferential direction and did not exceed 62,052 kPa (tension). Tensile hoop stress bands were distributed axially in this calculation (Figure 13). The minimum principle stresses in the skin were oriented axially and averaged less than 13,789 kPa (compression) in regions away from the axial ribs (Figure 14). The minimum principle stress in the ribs was oriented along the direction of the ribs. Axial rib stresses typically exceeded diagonal rib stresses by factors of 2 to 4 and reached average values or roughly 275,790 kPa in the middle shell.

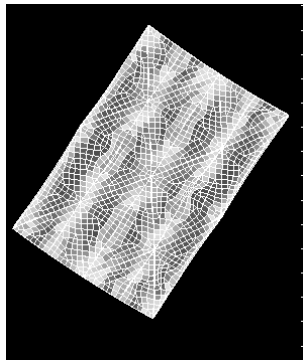
Figure 14. Minimum Principal Stress (Axial Skin Stresses)

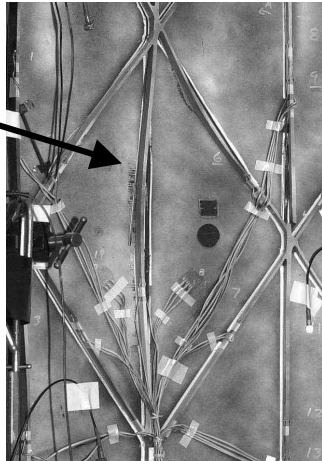
Location of
Initial Axial Rib
Buckle

Photo 3. Close-up of Initial Rib Buckle and Joint Failure.

High-speed video suggested that joint de-bonding and concurrent axial rib buckling might have initiated in one rib just prior to failure (Photos 2 and 3).

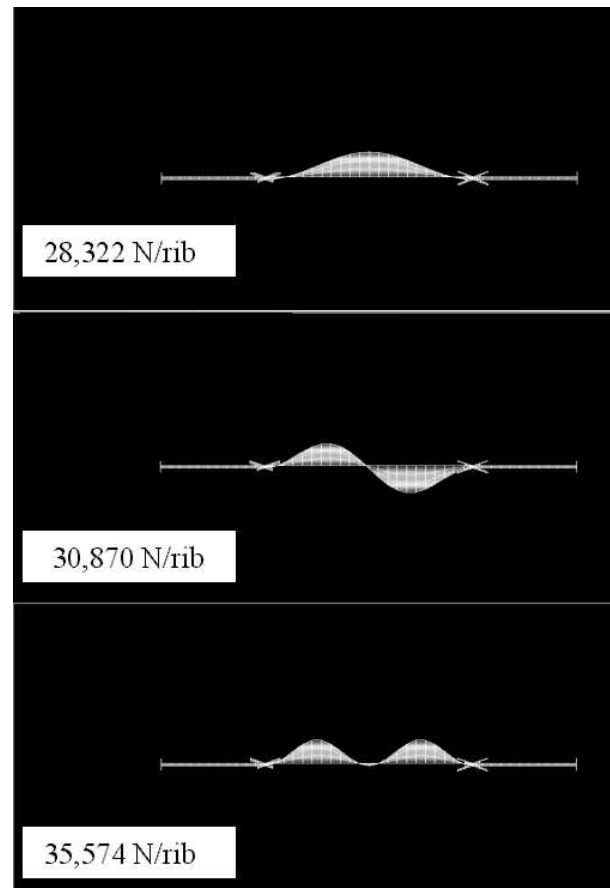
Figure 15. First Three Axial Rib Buckling Modes from Approximate Boundary Condition Analysis.

Additionally, a simplified buckling calculation was performed for one axial rib (the rib initiating failure in the test) using approximate boundary conditions: rib intersection nodes were clamped except in the axial direction, the inner radius rib edge was free, and the outer radius rib edge was restrained against circumferential and radial displacement (approximating the confinement of the skin). The first few buckling modes demonstrate buckling loads consistent with the observed buckling failure assuming that the axial ribs carried 75 to 95 percent of the total panel load (Figure 15).

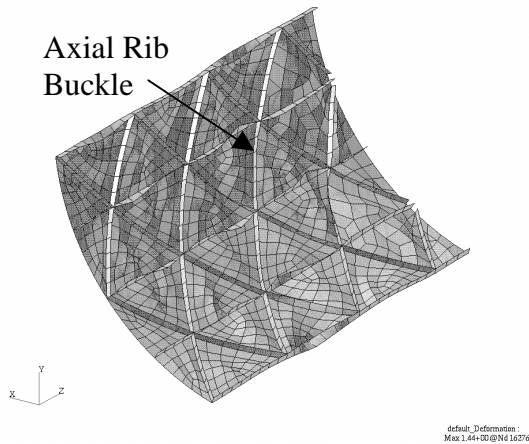
Figure 16. Deformed Shape at Final Converged Load Step of Post Buckling Analysis, Scale 2:1

For example, in preparation for tests of optimized panel designs to be conducted in February 2001, Boeing performed post-buckling analysis of a panel with a three-ply skin (90/0/90). The skin buckles very early, but still provides lateral support to the ribs (Figure 16). The maximum predicted panel load was 132 kN (Figure 17). Buckling of axial ribs is indicated by the rapidly increasing radial displacement of the ribs in the region of buckling (Figure 18). Note that rapid growth in radial rib deformation occurred at loads above 104 kN, or about 20% below the panel critical load.

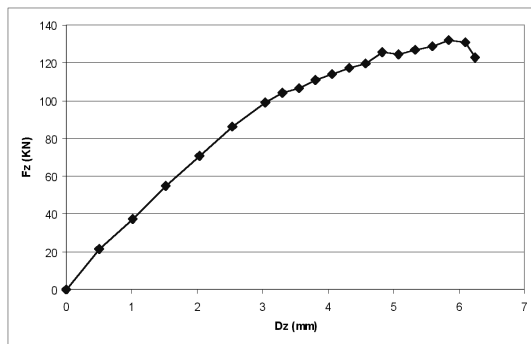
Figure 17. Analysis of Optimized Panel, 2-tows Axial Stiffeners, Total Axial Load vs. Axial Deformation

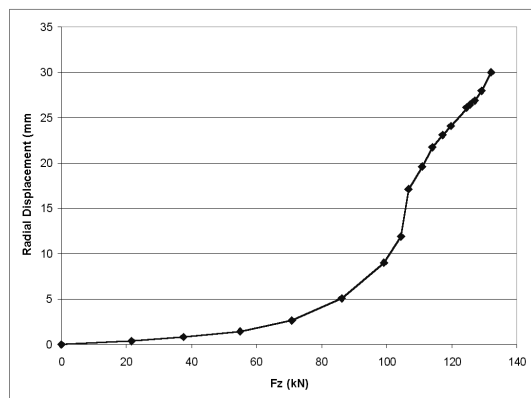
Figure 18. Optimized Panel, 2-tows Axial Stiffeners, Rib Radial Displacement vs. Panel Axial Load

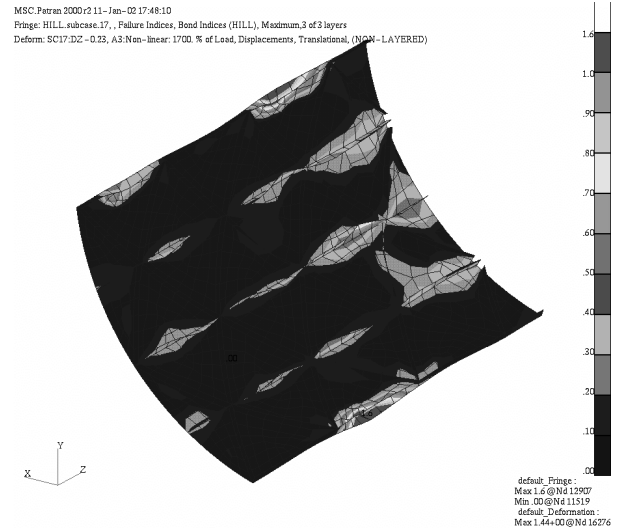
Figure 19. Optimized Panel, 2-tows Axial Stiffeners, Hill Failure Index

Localized peaking of the Hill Failure Index in the region of the rib buckling is high enough to indicate skin failure might occur prior to the buckling critical load (Figure 19). However, actual test data and more
